NEEDS ASSESSMENT REPORT OF LEA BAUDA, BARKIN LADI LGEA. AUGUST 2024.

INSUFFICIENT CLASSROOMS IN THE SCHOOL.

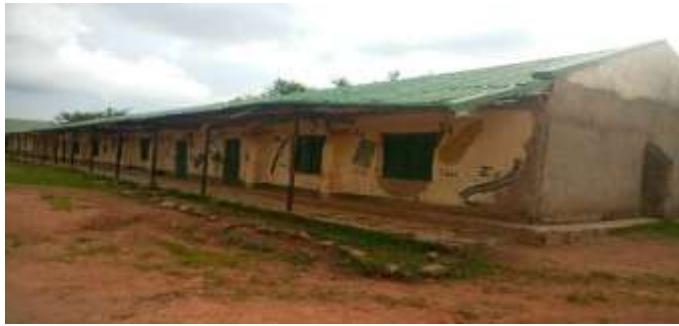
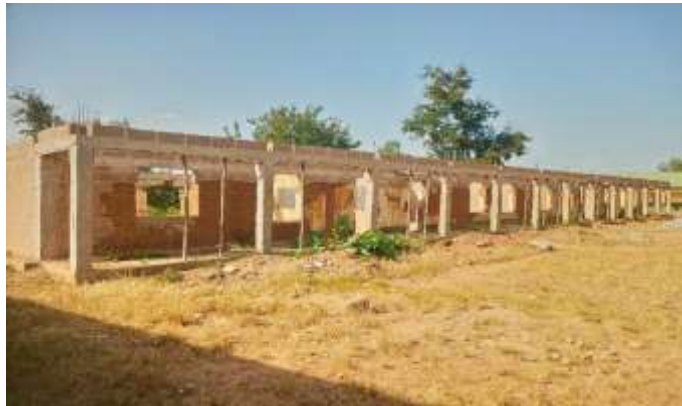
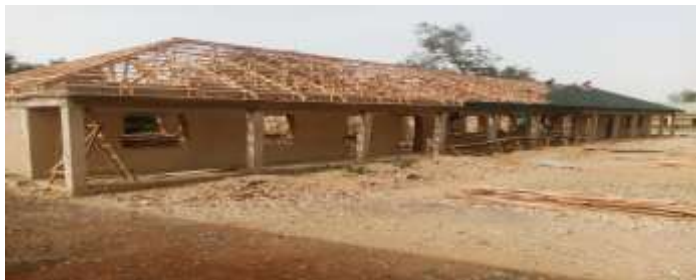
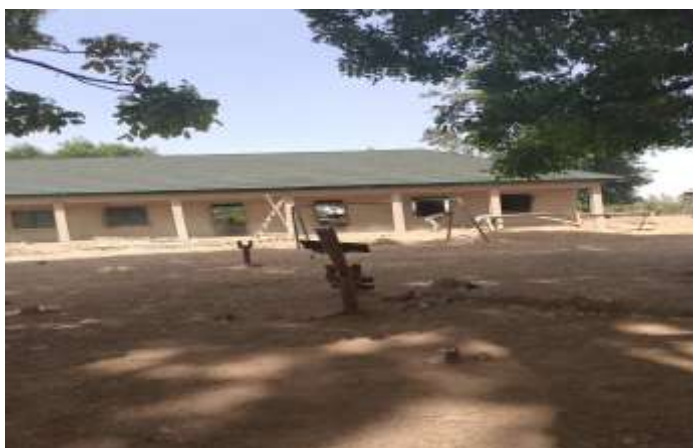
NEEDS ASSESSMENT REPORT OF LEA FAN-LOH, BARKIN LADI LGEA. AUGUST 2024.  
DILAPIDATED STANDARD MUD CLASSROOMS IN THE SCHOOL.

TO RENOVATE A BLOCK OF FOUR CLASSROOMS

- I. REMOVAL OF ROOF STRUCTURE
- II. PULLING DOWN OF WEAK WALLS
- III. SCRAPING OF WEAK PLASTER
- IV. BLOCKWORK TO ROOFING LEVEL
- V. CONCRETE COLUMNS AND BEAMS IN VERANDAH
- VI. WOOD WORK ON ROOF
- VII. ROOFING SHEETS (0.55MM GAUGE STONE COATED ALUMINIUM)
- VIII. FIXING OF METAL DOORS AND WINDOWS
- IX. PLASTERING
- X. SCREED FLOORING
- XI. PAINTING

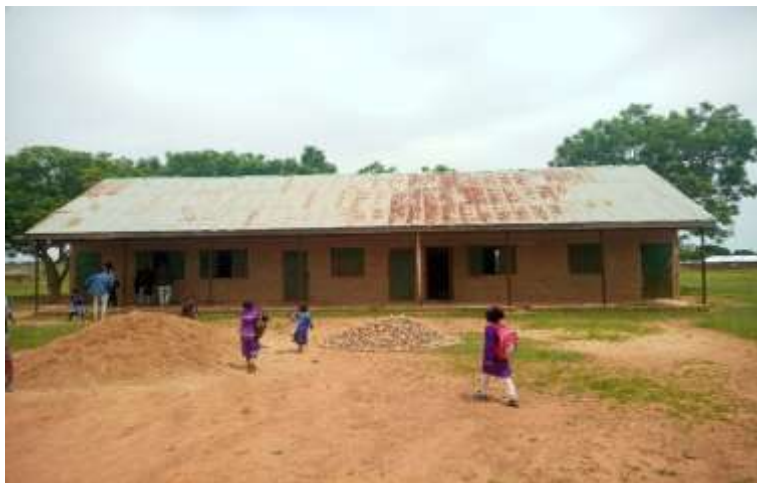
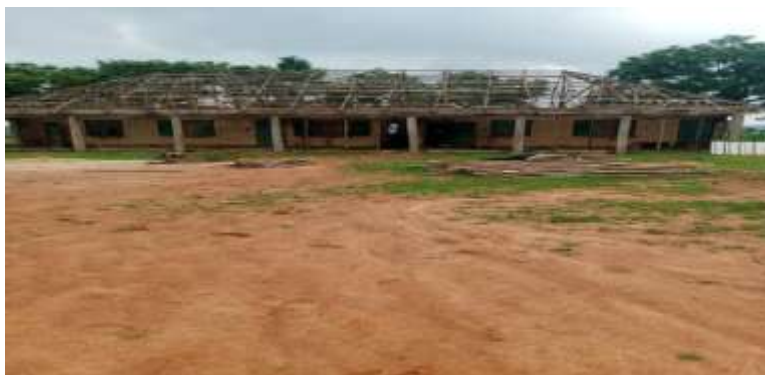
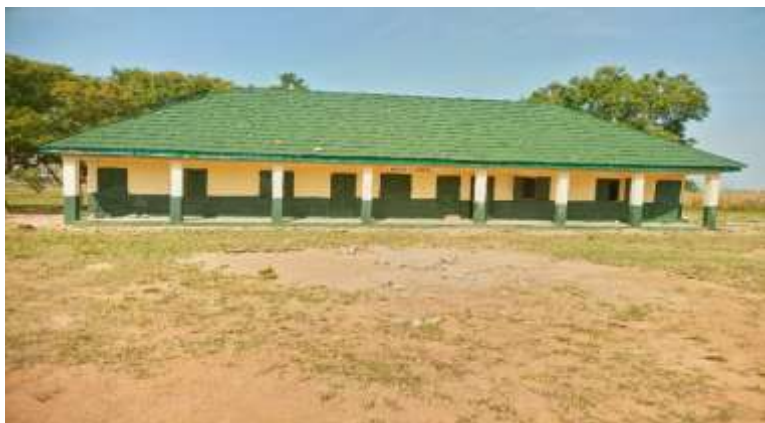
DILAPIDATED STANDARD CLASSROOMS IN THE SCHOOL.

TO RENOVATE A BLOCK OF TWO CLASSROOMS/OFFICE/ STORE

- I. REMOVAL OF ROOF STRUCTURE
- II. SCRAPE WEAK PLASTER
- III. BLOCKWORK TO ROOFING LEVEL
- IV. CONCRETE COLUMNS AND BEAMS IN VERANDAH
- V. WOOD WORK ON ROOF
- VI. ROOFING SHEETS (0.55MM GAUGE STONE COATED ALUMINIUM)
- VII. FIXING OF METAL DOORS AND WINDOWS
- VIII. PLASTERING
- IX. SCREED FLOORING
- X. PAINTING

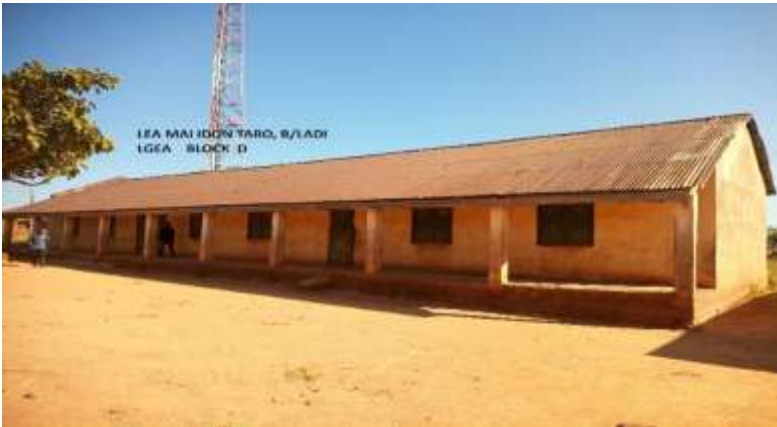
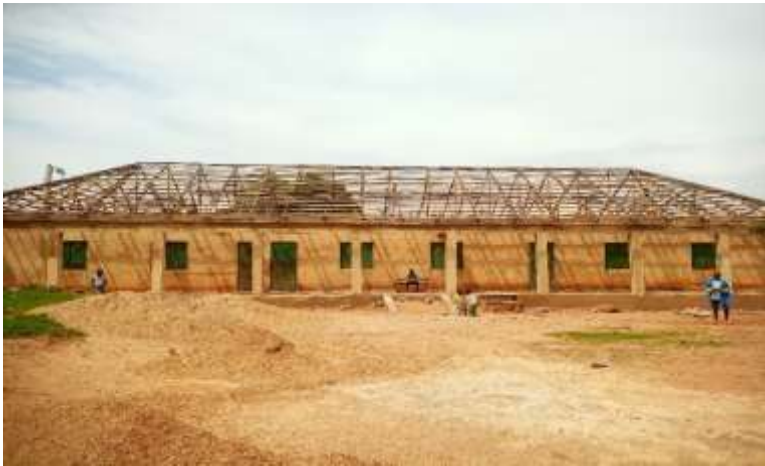
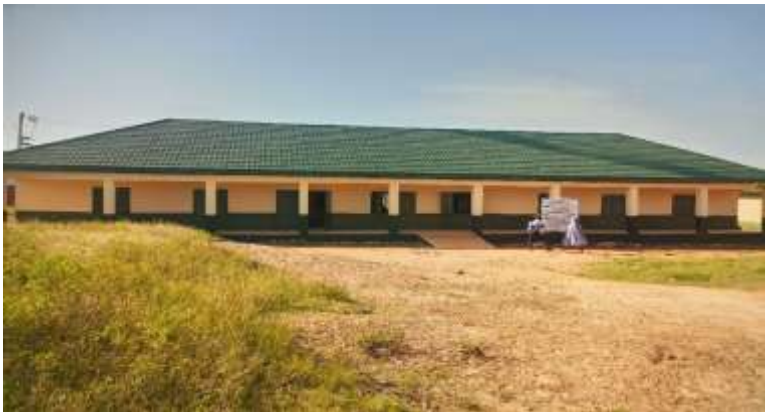
NEEDS ASSESSMENT REPORT OF LEA MAI IDON TARO, BARKIN LADI LGEA. AUGUST 2024.  
DILAPIDATED STANDARD CLASSROOMS IN THE SCHOOL.

TO RENOVATE A BLOCK OF THREE CLASSROOMS

- I. REMOVAL OF ROOF STRUCTURE
- II. SCRAPING OF WEAK FLOOR AND PLASTER
- III. BLOCKWORK TO ROOFING LEVEL
- IV. CONCRETE COLUMNS AND BEAMS IN VERANDAH
- V. WOOD WORK ON ROOF
- VI. ROOFING SHEETS (0.55MM GAUGE STONE COATED ALUMINIUM)
- VII. FIXING OF METAL DOORS AND WINDOWS
- VIII. PLASTERING
- IX. SCREED FLOORING
- X. PAINTING

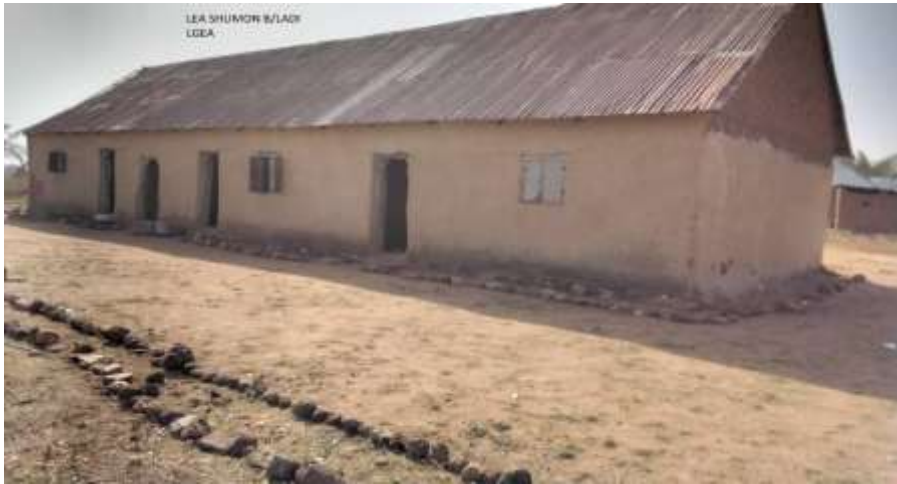
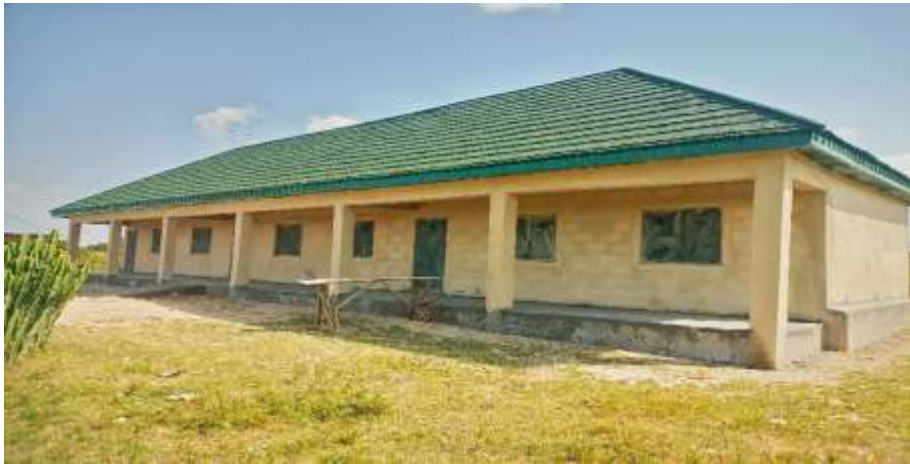
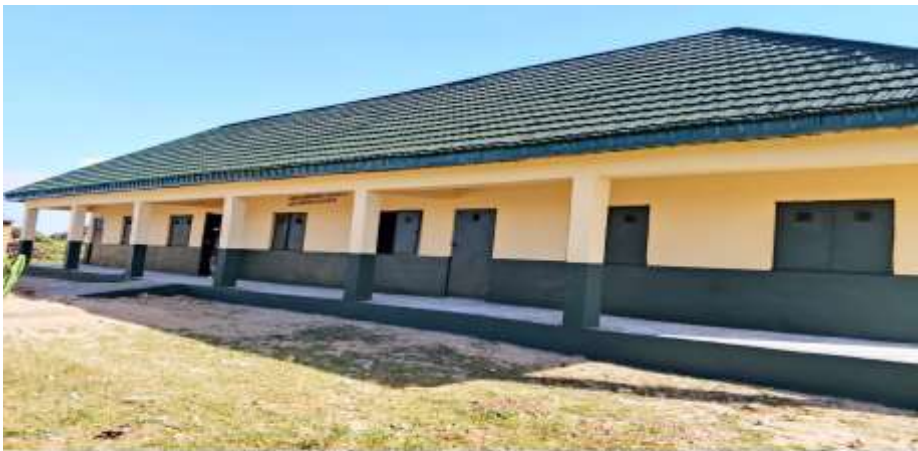
NEEDS ASSESSMENT REPORT OF LEA SHUMON, BARKIN LADI LGEA. AUGUST 2024.  
DILAPIDATED STANDARD MUD CLASSROOMS IN THE SCHOOL.

TO RENOVATE A BLOCK OF THREE CLASSROOMS

- I. REMOVAL OF ROOF STRUCTURE
- II. SCRAPING OF WEAK FLOOR AND PLASTER
- III. BLOCKWORK TO ROOFING LEVEL
- IV. CONCRETE COLUMNS AND BEAMS IN VERANDAH
- V. WOOD WORK ON ROOF
- VI. ROOFING SHEETS (0.55MM GAUGE STONE COATED ALUMINIUM)
- VII. FIXING OF METAL DOORS AND WINDOWS
- VIII. PLASTERING
- IX. SCREED FLOORING
- X. PAINTING
