NEEDS ASSESSMENT REPORT OF LEA BAUDA, BARKIN LADI LGEA. AUGUST 2024.

INSUFFICIENT CLASSROOMS IN THE SCHOOL.

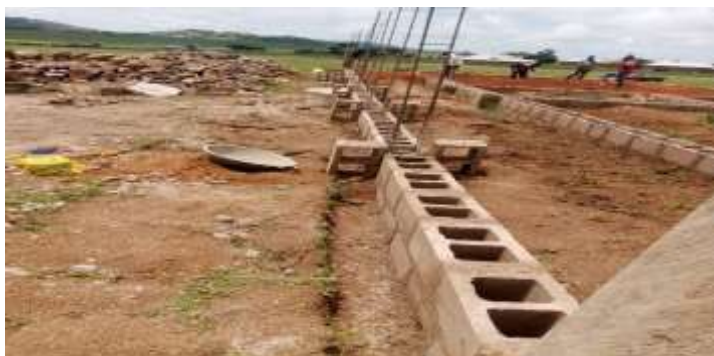
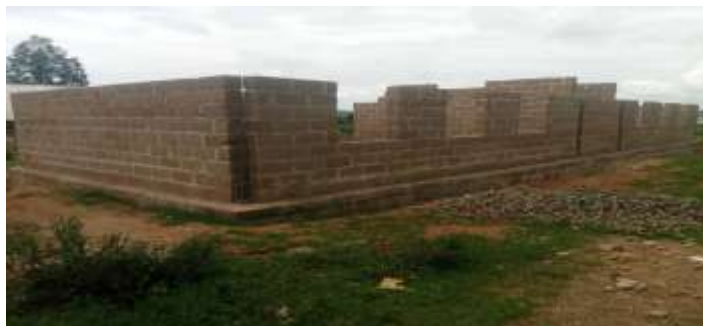
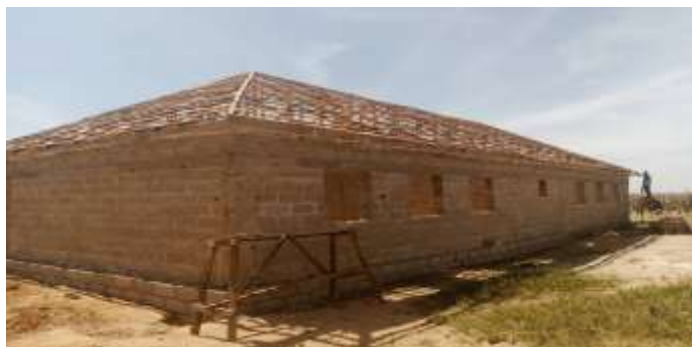
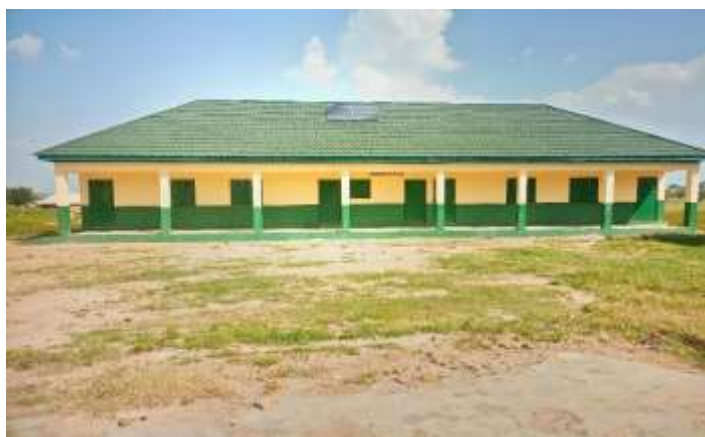
## PROGRESS PICTURES

INSUFFICIENT CLASSROOMS IN THE SCHOOL.

TO BUILD NEW CLASSROOMS

- I. EXCAVATION OF FOUNDATION TRENCHES
- II. FOUNDATION WORK (INCLUDING RAMP)
- III. BLOCKWORK TO ROOFING LEVEL
- IV. CONCRETE COLUMNS AND BEAMS IN VERANDAH
- V. WOOD WORK ON ROOF
- VI. ROOFING SHEETS (0.55MM GAUGE STONE COATED ALUMINIUM)
- VII. FIXING OF METAL DOORS AND WINDOWS
- VIII. NEW PLASTERING
- IX. TERRAZZO FLOORING
- X. PAINTING
- XI. SOLAR INSTALLATIONS

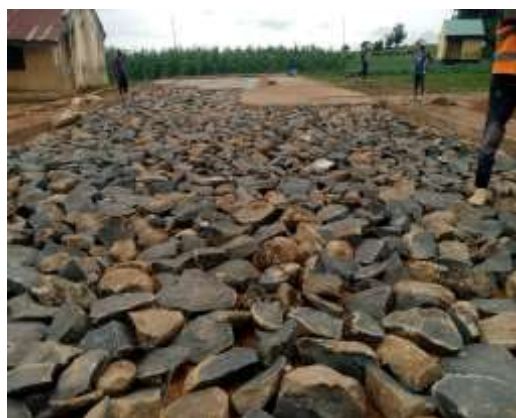
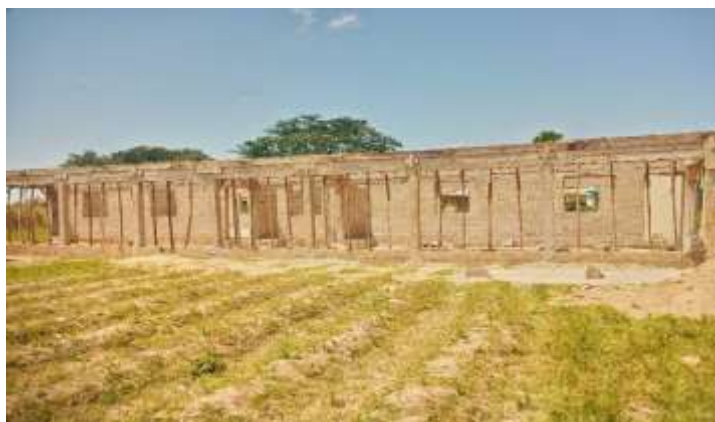
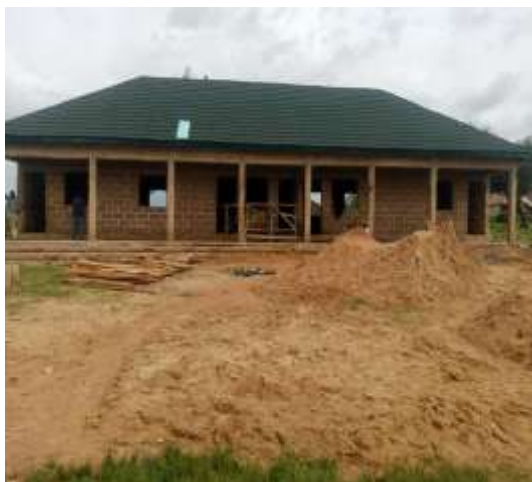
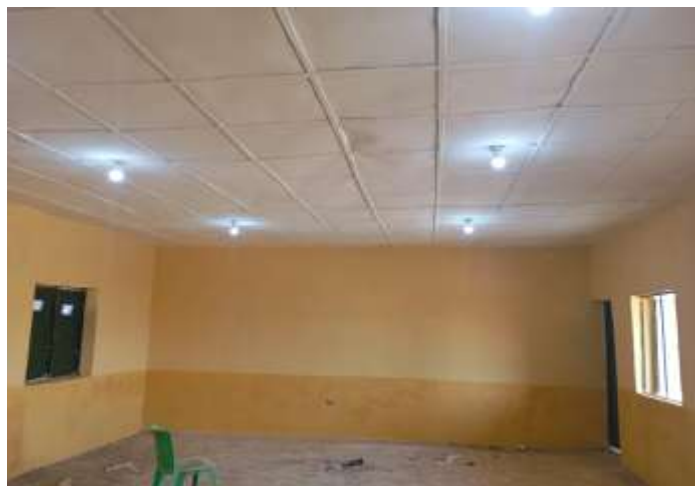
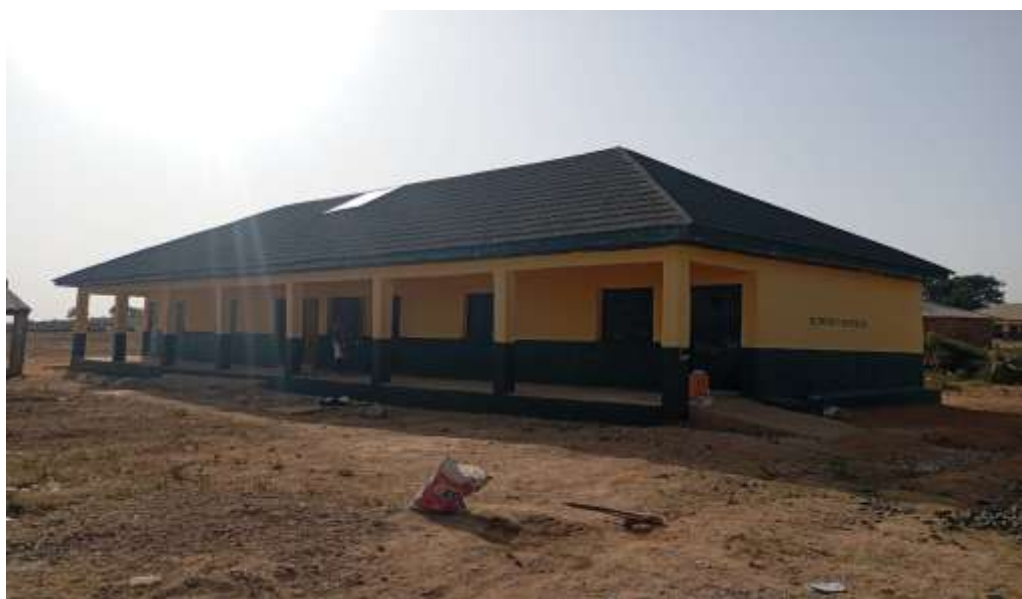
## PROGRESS PICTURES

INSUFFICIENT CLASSROOMS IN THE SCHOOL.

TO BUILD NEW CLASSROOMS

- I. EXCAVATION OF FOUNDATION TRENCHES
- II. FOUNDATION WORK (INCLUDING RAMP)
- III. BLOCKWORK TO ROOFING LEVEL
- IV. CONCRETE COLUMNS AND BEAMS IN VERANDAH
- V. WOOD WORK ON ROOF
- VI. ROOFING SHEETS (0.55MM GAUGE STONE COATED ALUMINIUM)
- VII. FIXING OF METAL DOORS AND WINDOWS
- VIII. NEW PLASTERING
- IX. TERRAZZO FLOORING
- X. PAINTING
- XI. SOLAR INSTALLATIONS

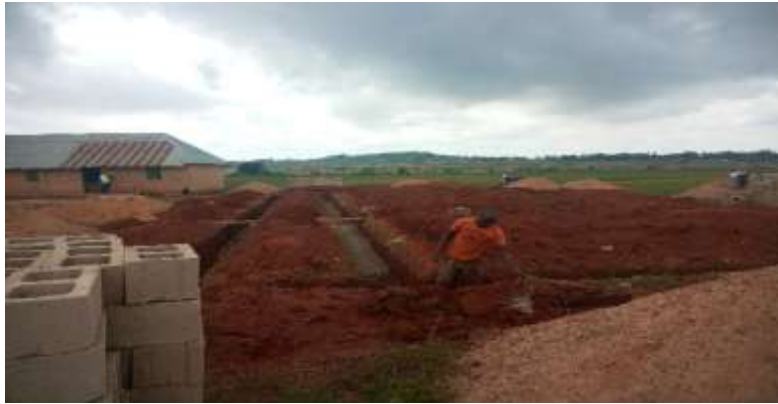
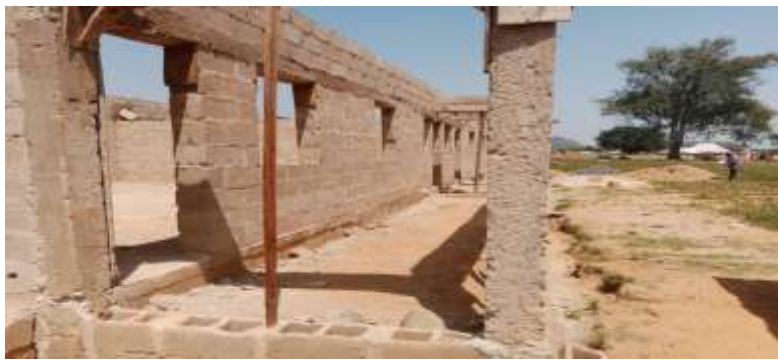
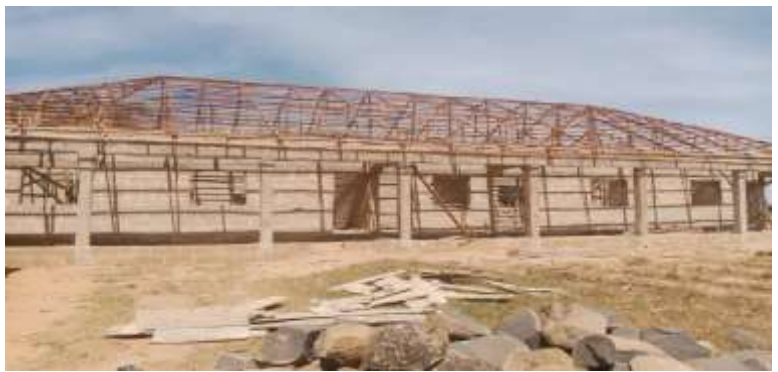
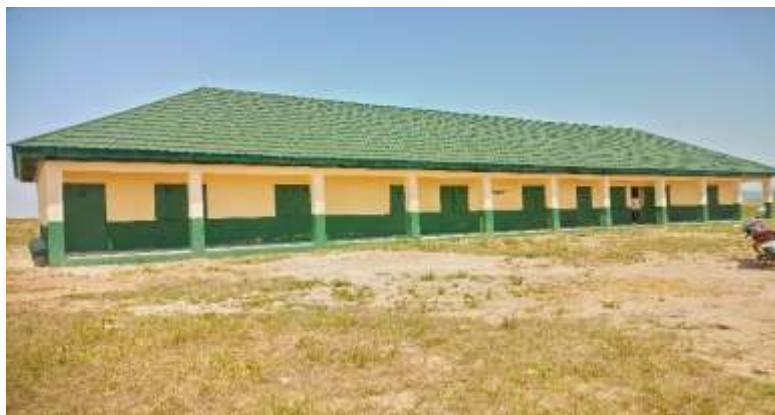
## PROGRESS PICTURES

NEEDS ASSESSMENT REPORT OF LEA HURUM-GASHISH, BARKIN LADI LGEA. AUGUST 2024.  
INSUFFICIENT CLASSROOMS IN THE SCHOOL.

TO BUILD NEW CLASSROOMS

- I. EXCAVATION OF FOUNDATION TRENCHES
- II. FOUNDATION WORK (INCLUDING RAMP)
- III. BLOCKWORK TO ROOFING LEVEL
- IV. CONCRETE COLUMNS AND BEAMS IN VERANDAH
- V. WOOD WORK ON ROOF
- VI. ROOFING SHEETS (0.55MM GAUGE STONE COATED ALUMINIUM)
- VII. FIXING OF METAL DOORS AND WINDOWS
- VIII. NEW PLASTERING
- IX. TERRAZZO FLOORING
- X. PAINTING
- XI. SOLAR INSTALLATIONS

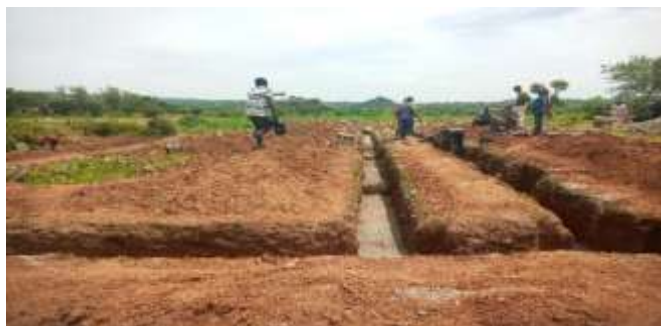
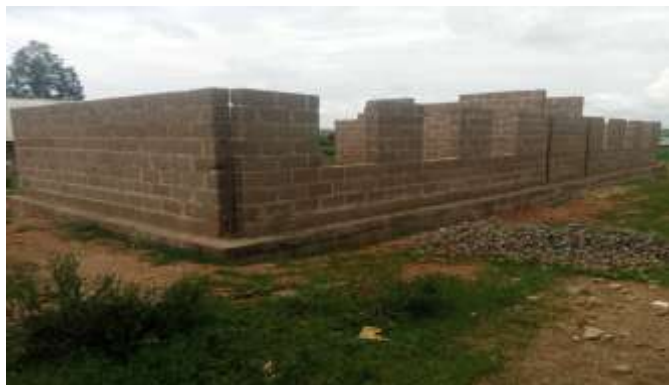
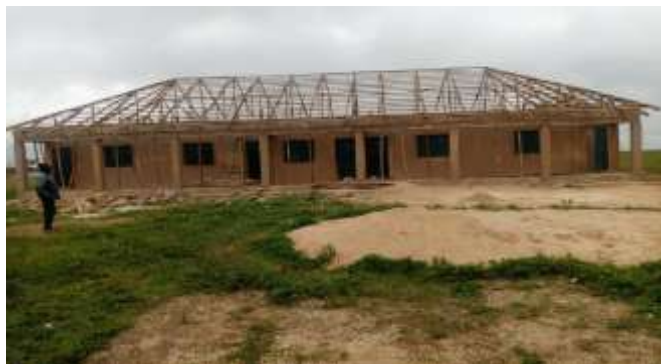
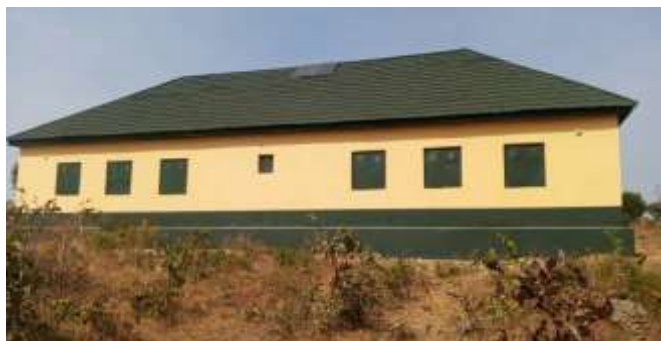
## PROGRESS PICTURES

INSUFFICIENT CLASSROOMS IN THE SCHOOL.

TO BUILD NEW CLASSROOMS

- I. EXCAVATION OF FOUNDATION TRENCHES
- II. FOUNDATION WORK (INCLUDING RAMP)
- III. BLOCKWORK TO ROOFING LEVEL
- IV. CONCRETE COLUMNS AND BEAMS IN VERANDAH
- V. WOOD WORK ON ROOF
- VI. ROOFING SHEETS (0.55MM GAUGE STONE COATED ALUMINIUM)
- VII. FIXING OF METAL DOORS AND WINDOWS
- VIII. NEW PLASTERING
- IX. TERRAZZO FLOORING
- X. PAINTING
- XI. SOLAR INSTALLATIONS
